MNM Fatal 2005-28

- Fall of Person
- October 12, 2005 (Ohio)
- Industrial Sand Operation
- Bagger
- 37 years old
- 10 weeks mining experience

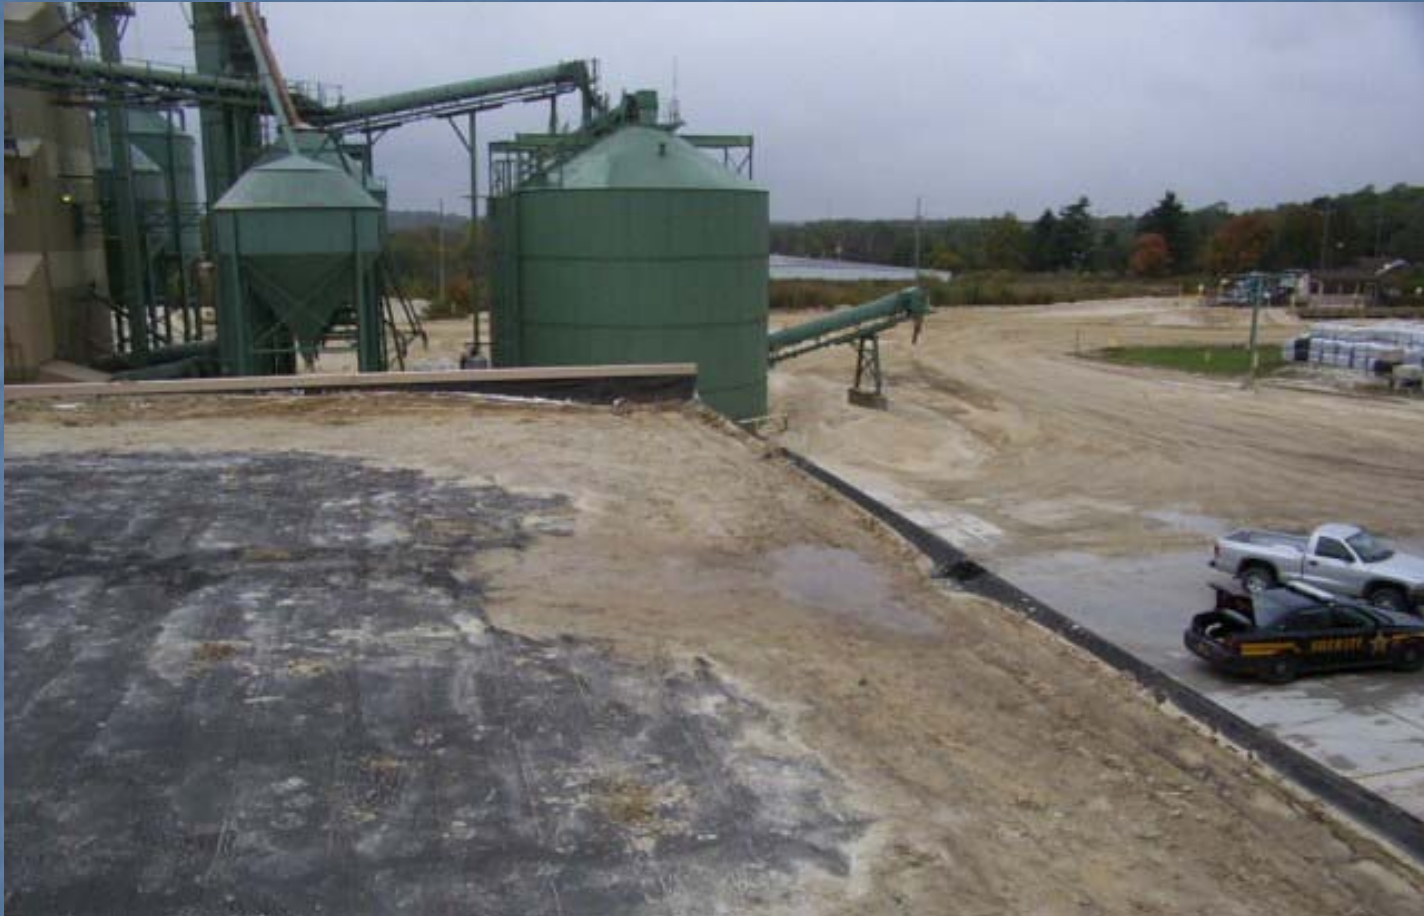
The victim was shoveling sand that had accumulated along the edges of the roof of a bulk bag warehouse. He fell 17.5 feet to a loading dock below.

Safe work procedures were inadequate. Personnel assigned to shovel accumulations of material on the edge of the roof were not briefed regarding the use of fall protection when the task was assigned. The victim shoveled parallel to the edge of the roof without wearing a safety belt secured to a line. No anchorage points to secure a line had been installed.

- Stop, Look, Analyze, and Manage (SLAM) each task to identify all potential hazards. Initiate action to protect yourself when performing every task.
- Train all miners to recognize health and safety hazards of the assigned task and ensure that steps are taken to safely complete the task.
- Always wear appropriate fall protective equipment where hazards from falling exist.
